**Flood Control Project Maintenance**  
**2019 Structure Summary Report**  
**Overall Unit and Item Ratings**

**City of Sacramento**

**El Camino Avenue Bridge**

**Magpie Creek Pumping Plant**

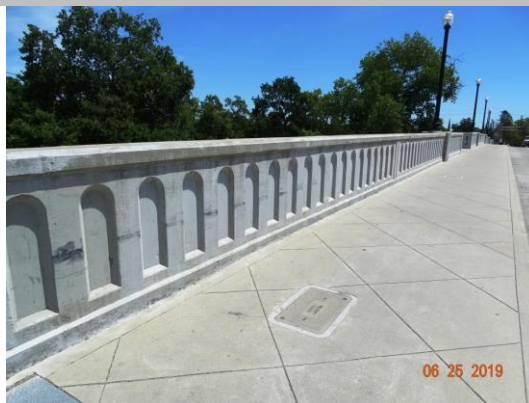
Photo 4 of 5 : ST\_2019\_NA0005\_221\_1\_20190626\_00030.jpg

LM Start	0.00	Rating **	N	Issue No.	1 (cont)	
LM End	0.00	Issue Type +	Ma	Location *	WS	
Category	Structures & Concrete Lined Channels			GPS Latitude/Longitude		
				Start		End
Item	Photo Documentation			38.611365 °		38.611365 °
				-121.466557 °		-121.466557 °
DWR ID	DWR_NA0005_221_t_2012_1					
Action/Comments						
Inspector Comments: West El Camino bridge is inspected as a structure, because the bridge deck is below the design water surface elevation, causing the wingwalls and guard railing to act as flood walls during high water events.

View of the northwest wing wall to act as a flood wall at this structure. Summer 2019

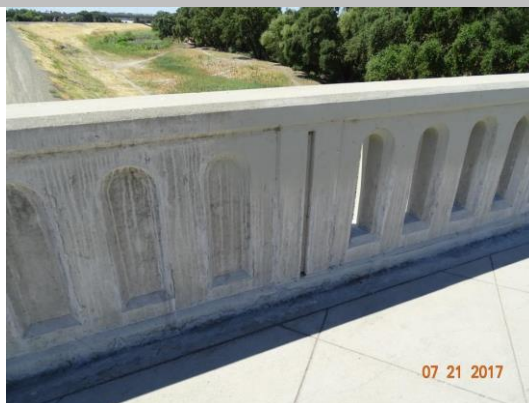
Photo 5 of 5 : ST\_2019\_NA0005\_221\_1\_20190619\_00006.jpg

View of the separation between the wingwall and guardrail. Summer 2017

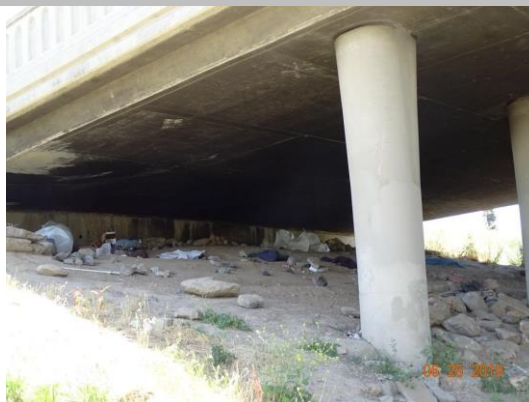
Photo 1 of 2 : ST\_2019\_NA0005\_221\_5\_20190627\_00037.jpg

LM Start	0.00	Rating **	M	Issue No.	5
LM End	0.00	Issue Type +	Ma	Location *	WS
Category	Structures & Concrete Lined Channels	GPS Latitude/Longitude			
		Start	End		
Item	Revetments	38.611365 °		38.611365 °	
		-121.466557 °		-121.466557 °	
DWR ID	DWR_NA0005_221_t_2012_5				
Action/Comments					
Inspector Comments: Riprap underneath the bridge appears to be displaced by the homeless.

View of revetment underneath the east end of the bridge. Summer 2019

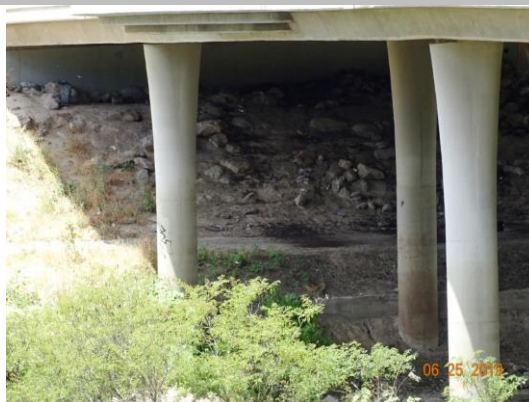
Photo 2 of 2 : ST\_2019\_NA0005\_221\_5\_20190627\_00038.jpg

View of revetment underneath the west end of the bridge. Summer 2019

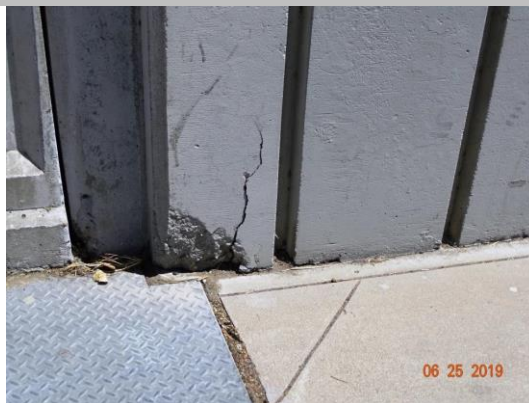
Photo 1 of 4 : ST\_2019\_NA0005\_221\_15\_20190627\_00039.jpg

LM Start	0.00	Rating **	A	Issue No.	15
LM End	0.00	Issue Type +	Ma	Location *	WS
Category	Structures & Concrete Lined Channels			GPS Latitude/Longitude	
				Start	End
Item	Concrete Surfaces			38.611365 °	38.611365 °
				-121.466557 °	-121.466557 °
DWR ID	DWR_NA0005_221_t_2019_15				
Action/Comments					
Inspector Comments: There is minor spalling and cracking at the north ends of the bridge.

View of minor cracking at the northeast end of the bridge. Summer 2019

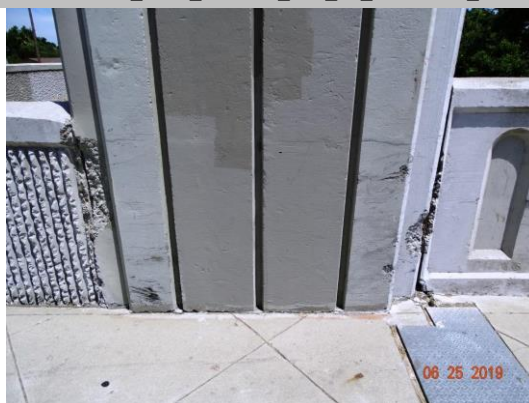
Photo 2 of 4 : ST\_2019\_NA0005\_221\_15\_20190627\_00040.jpg

View of minor spalling at the northwest end of the bridge. Summer 2019

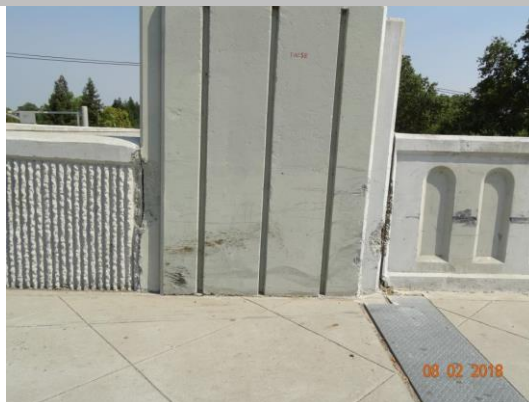
Photo 3 of 4 : ST\_2019\_NA0005\_221\_15\_20190619\_00013.jpg

View of minor spalling at the northwest end of the bridge. Summer 2018

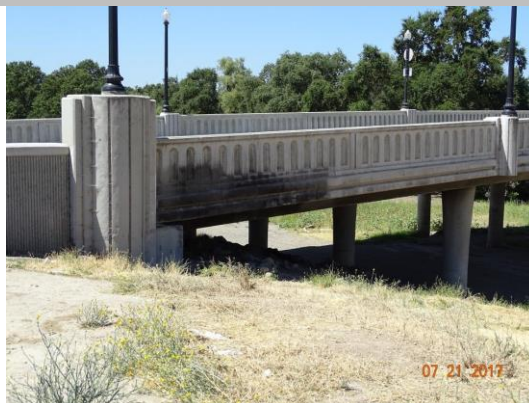
Photo 4 of 4 : ST\_2019\_NA0005\_221\_15\_20190619\_00016.jpg

View of the flood wall that appears to have smoke damage, but the joints and the integrity of the wall do not appear to be threatened. Summer 2017

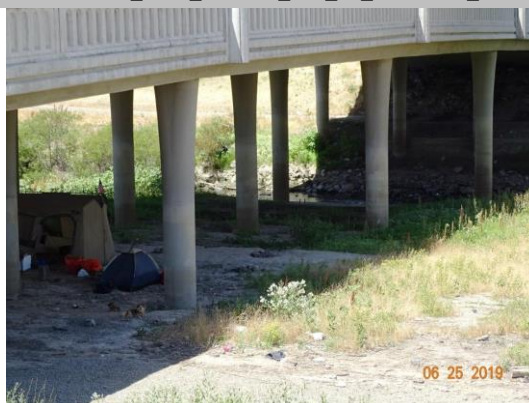
Photo 1 of 2 : ST\_2019\_NA0005\_221\_17\_20190627\_00041.jpg

LM Start	0.00	Rating **	A	Issue No.	17
LM End	0.00	Issue Type +	Ma	Location *	WS
Category	Structures & Concrete Lined Channels			GPS Latitude/Longitude	
				Start	End
Item	Concrete Foundations			38.611365 °	38.611365 °
				-121.466557 °	-121.466557 °
DWR ID	DWR_NA0005_221_t_2012_17				
Action/Comments					
Inspector Comments: There is no apparent scouring or erosion at the footings of the structure.

View looking west at the bridge piers. Summer 2019

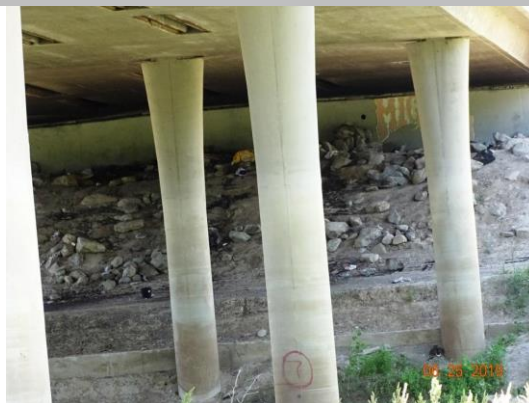
Photo 2 of 2 : ST\_2019\_NA0005\_221\_17\_20190627\_00043.jpg

LM Start	0.00	Rating **	A	Issue No.	17 (cont)
LM End	0.00	Issue Type +	Ma	Location *	WS
Category	Structures & Concrete Lined Channels	GPS Latitude/Longitude			
		Start		End	
Item	Concrete Foundations	38.611365 °		38.611365 °	
		-121.466557 °		-121.466557 °	
DWR ID	DWR_NA0005_221_t _ 2012_17				
Action/Comments					
Inspector Comments: There is no apparent scouring or erosion at the footings of the structure.

View looking west at the bridge piers. Summer 2019

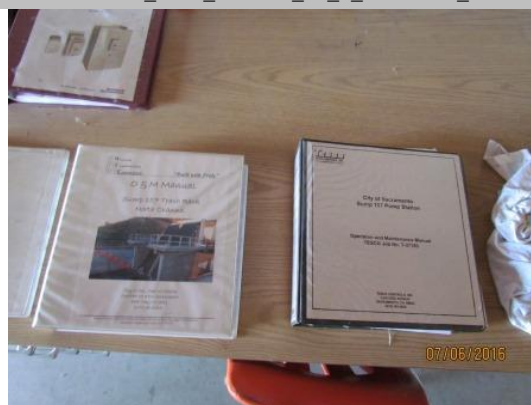
Photo 2 of 2 : ST\_2019\_NA0005\_16\_2\_20190619\_00003.jpg

View of O&amp;M manuals in the plant, but they are not written by the USACE. Summer 2017

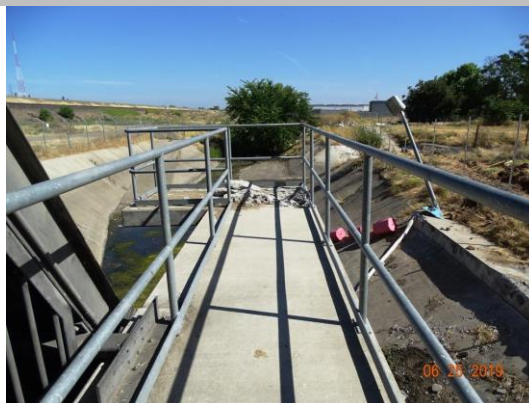
Photo 1 of 5 : ST\_2019\_NA0005\_16\_5\_20190628\_00057.jpg

LM Start	0.00	Rating **	M	Issue No.	5
LM End	0.00	Issue Type +	Ma	Location *	
Category	Pump Stations			GPS Latitude/Longitude	
				Start	End
Item	Safety			38.640967 °	38.640967 °
				-121.471106 °	-121.471106 °
DWR ID	DWR_NA0005_16_t_2012_5				
Action/Comments					
Inspector Comments: Repair damaged concrete walkway and metal railings from a vehicular rollover accident off of overpass.

View of damaged walkway near Duperon screens due to a vehicular rollover accident from overpass. Summer 2019

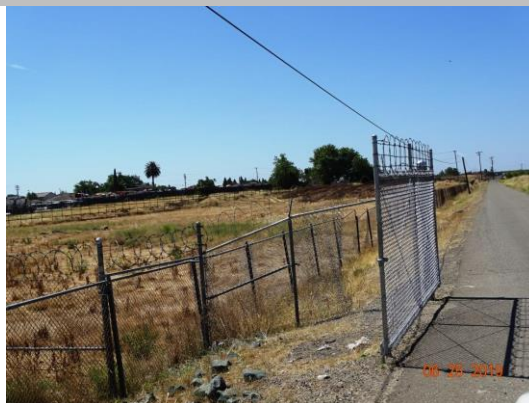
Photo 1 of 3 : ST\_2019\_NA0005\_16\_21\_20190626\_00052.jpg

View of cut fence at the main entrance. Summer 2019

LM Start	0.00	Rating **	M	Issue No.	21
LM End	0.00	Issue Type +	Ma	Location *	
Category	Pump Stations			GPS Latitude/Longitude	
				Start	End
Item	Security Fencing			38.640967 °	38.640967 °
				-121.471106 °	-121.471106 °
DWR ID	DWR_NA0005_16_t_2012_21				
Action/Comments					
Inspector Comments: Repair and reinforce fencing.

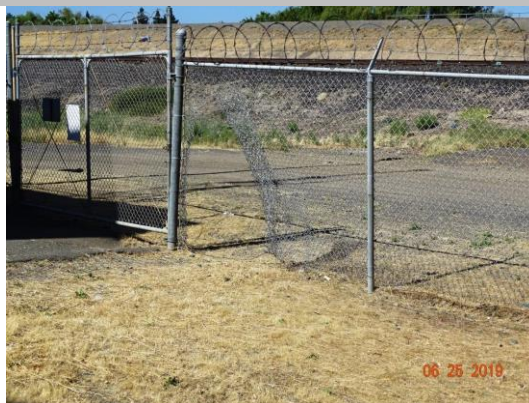
Photo 2 of 3 : ST\_2019\_NA0005\_16\_21\_20190626\_00049.jpg

View of cut fence along the west side of property. Summer 2019

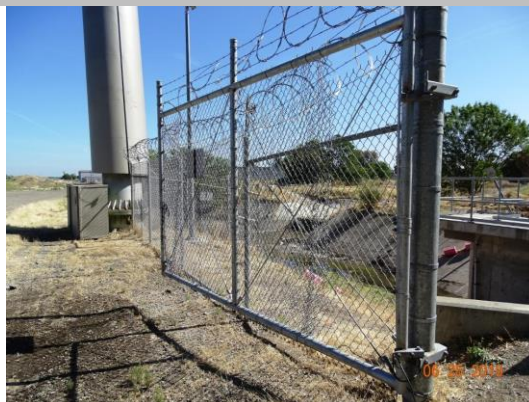
Photo 3 of 3 : ST\_2019\_NA0005\_16\_21\_20190626\_00051.jpg

View of cut fence next to the trash rake gate. Summer 2019

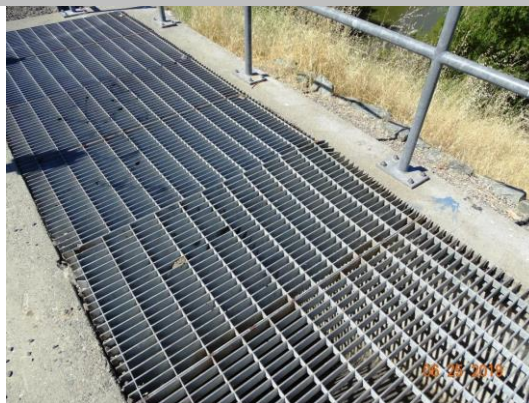
Photo 2 of 3 : ST\_2019\_NA0005\_16\_22\_20190626\_00054.jpg

View of bent grate over discharge pipes. Summer 2019

LM Start	0.00	Rating **	A	Issue No.	22
LM End	0.00	Issue Type +	Ma	Location *	
Category	Pump Stations			GPS Latitude/Longitude	
				Start	End
Item	Intake and Discharge Pipes			38.640967°	38.640967°
				-121.471106°	-121.471106°
DWR ID	DWR_NA0005_16_t_2012_22				
Action/Comments					
Inspector Comments: Repair and secure grate over discharge pipes.
